**NASA TM X-1195**

**ANALYSIS OF AN EMERGENCY  
DECELERATION AND DESCENT OF THE  
XB-70-1 AIRPLANE DUE TO ENGINE DAMAGE  
RESULTING FROM STRUCTURAL FAILURE**

*by Chester H. Wolowicz*

*Flight Research Center  
Edwards, Calif.*

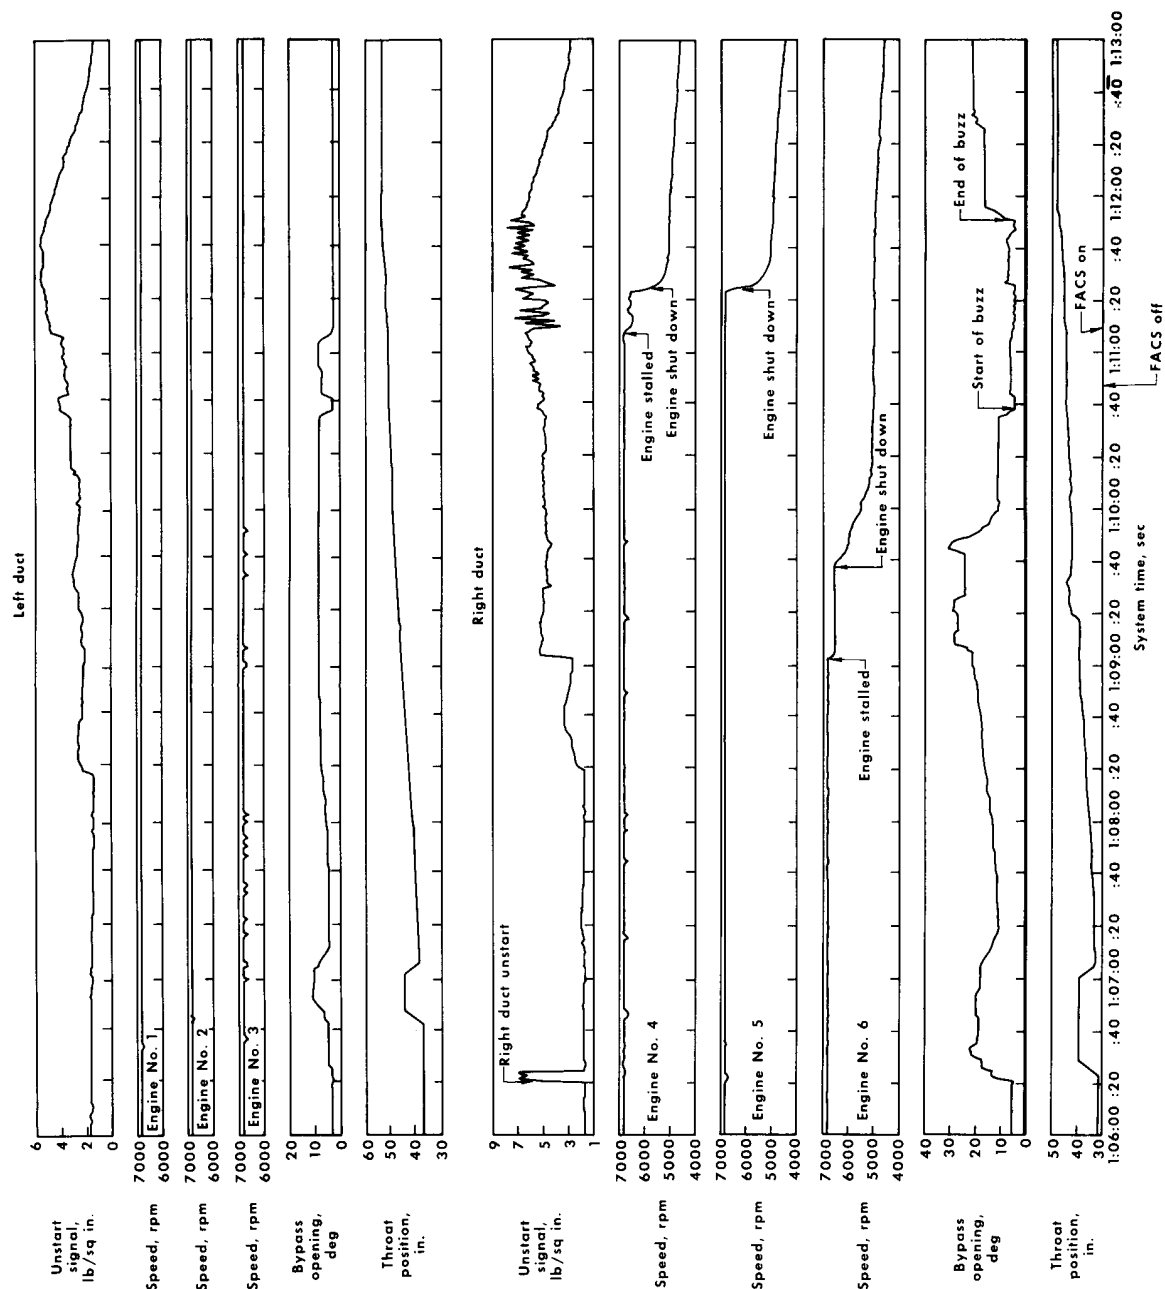
Figure 6. -- Time history of propulsion-system performance. XB-70-1; flight 12.

After succeeding in returning the shock to its started position, the pilot closed the right bypass doors toward their original position (fig. 6) and returned the throat control to AUTO mode; however, because of the damage to the engines and the consequent reduction in the engine airflow, it became necessary to set the doors to  $11^\circ$ , rather than the original  $4^\circ$ , to bring the shock to its proper operating position. The subsequent opening of the right bypass doors from  $11^\circ$  to  $21^\circ$  to keep the normal shock in proper position was, to a large extent, dictated by the gradual deterioration in airflow through the damaged engines as well as a deceleration from  $M = 2.5$  to 2.2 in the time interval 1:07:20 to 1:09:03. (Within this interval, engine No. 5 was throttled to military power because of persistent vibration; all other engines were cut to minimum afterburner and began to show minimum afterburner instability. The minimum afterburner instability is not related to the problem generated by the damage to the engines. This instability is a problem related to the engines installed in the XB-70 and has been encountered numerous times. At time 1:08:16 to 1:08:20, because of the persistence of the instability (not illustrated in fig. 6), all engines except No. 5 were momentarily advanced in power and then retarded to military power for deceleration and descent to terminate the flight.)

throat. Because of the deteriorated condition of the damaged engines and the consequent reduced airflow conditions, as well as the reduction of aircraft speed, this bypass angle did not provide sufficient opening to restart the inlet. At  $M = 2.17$  (time 1:09:18) the unstart signal light went out, possibly leading the copilot to believe that the right-duct inlet had started. However, the light went out because of an automatic disarming of this warning system at  $M = 2.17$ , even though inlet start conditions prevail down to  $M = 2.0$ , as shown in figure 2(a). Inability to recover engine No. 6 from the stalled condition subsequently resulted in it being shut down at time 1:09:38 at  $M = 2.08$ . This was followed by a closing of the right bypass doors to  $11^\circ$ .

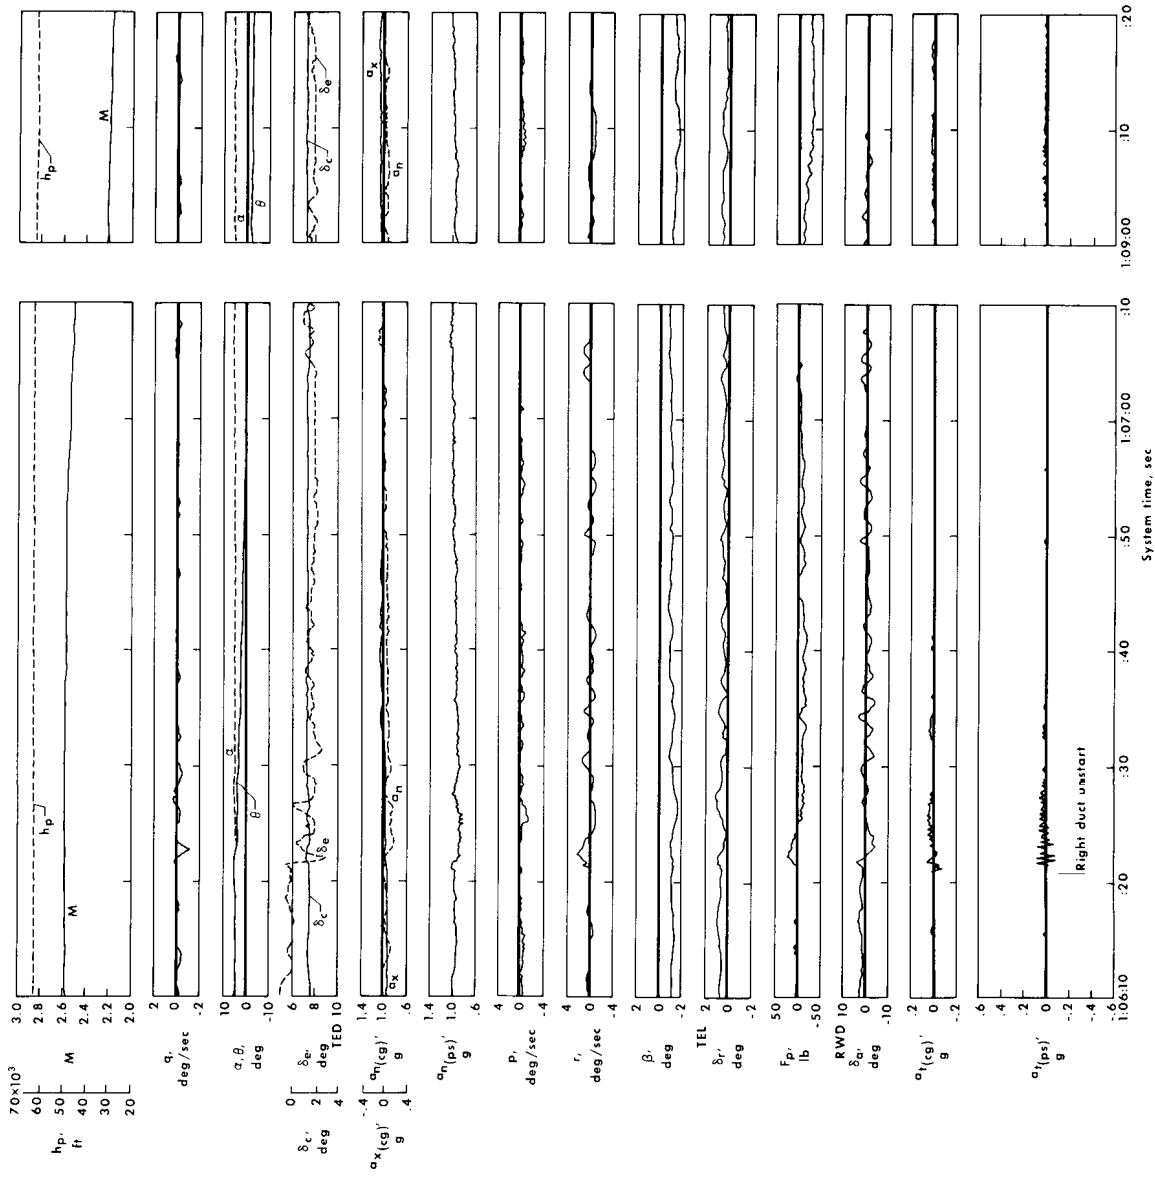
(a) System time = 1:06:10 to 1:09:20.

Initial indication of wing-apex failure and its ingestion into the right duct at the time the aircraft was flying at  $M = 2.6$  at 63,000 feet pressure altitude was evidenced by a local Mach disturbance at the duct and was also reflected in the shock-position pressure ratio. The copilot, observing the disturbance to the normal shock position in the right duct as noted on the shock-position indicator, but unaware of its cause, proceeded through normal corrective action to open the right-duct bypass doors to reposition the shock. At this time, on the basis of the pattern of damage done to the duct and its engines, a portion of the disintegrated apex struck engine No. 5, causing a momentary stall and a pronounced unstart signal from the right duct--as evidenced in figure 6 at time 1:06:21. The left duct shows normal operation at this time. The copilot apparently reacted to the unstart signal, to regain a started inlet condition, by continuing to open the bypass doors in the right duct. Less than a second later, he switched the throat to manual mode, which caused the throat to open and the inlet to start, since the manual control had been prepositioned to the restart position. The actions caused the normal shock to return to its throat position (start condition). Transverse resonant fuselage vibrations which were initiated by the unstart pulse (fig. 7(a)) damped out.
